## NASA Contractor Report 165664

# Advanced Composite Aileron For L-1011 Transport Aircraft-- Ground Tests And Flight Evaluation

**C.F. Griffin**

GROUND TESTS AND FLIGHT EVALUATION

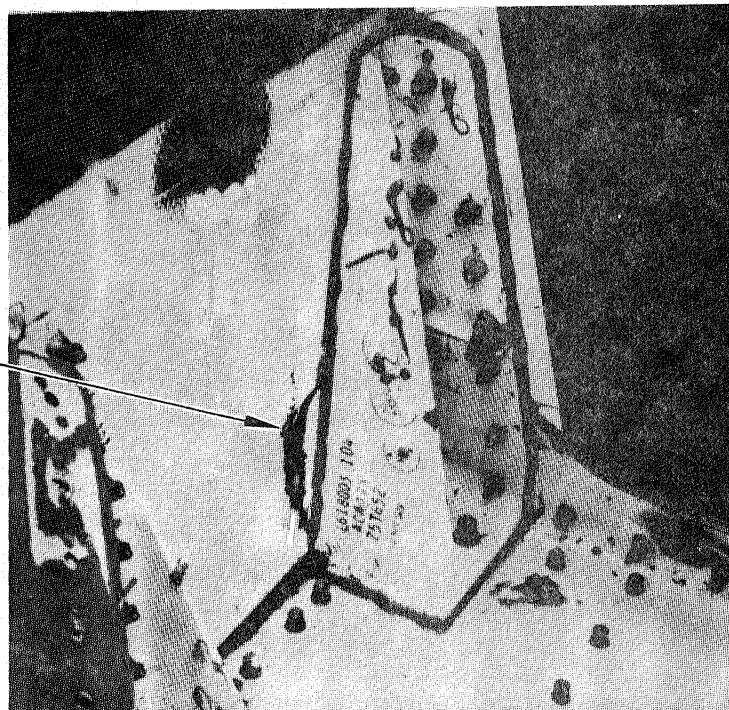
Failure location

main rib web failed in a post-buckling mode with the web tearing at the bathtub fitting near the front spar and failing in bending along the crest of the shear buckle (see figures 21 and 22). The main rib web at station 107.1 also failed in buckling with the bending failure crossing the two forward access holes (figures 23 and 24). It is not possible to distinguish the sequence of failure of these two ribs because the measured actuator link loads at I.A.S. 102.7 and I.A.S. 107.1 show a load drop-off at exactly the same instant.

Figure 22. - View of I.A.S. 102.7 rib showing Web failure-inboard side.

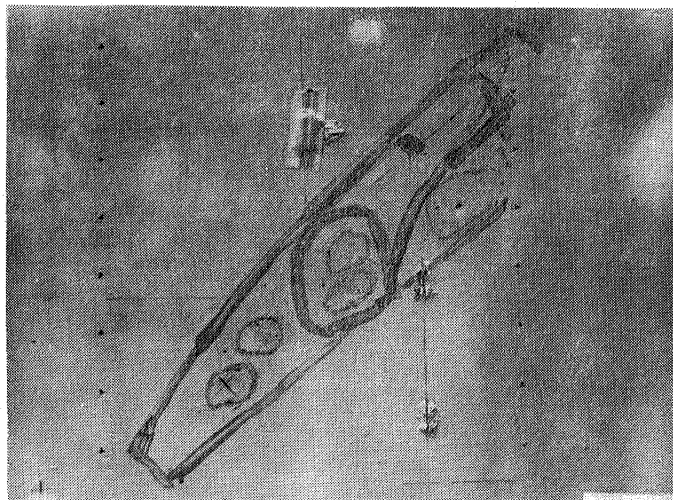
The area selected for the damage was the lower cover at I.A.S. 85.7, 191 mm (7.5 in) aft of the front spar. To simulate the damage from swept-stroke lightning the following procedure was utilized. The cover was subjected to five impacts of 10.8 J (8 ft-lb) of energy each along a 45° line spaced approximately 51 mm (2 in) apart. A 25.4 mm (1.0 in) diameter steel rod with a hemispherical tip was used to make these impacts. Ultra-sonic inspection of the cover after the impacts (shown in figure 28) verified that substantial delamination occurred over a region of 381 mm (15 in) by 76 mm (3 in). A welder's electric arc was then used to burn a hole in the middle of the delaminated area, see figure 29. An oxygen/acetylene torch was then used to burn the surface of the entire delaminated area. The resulting damage, shown on figure 30, satisfactorily simulated the effects of swept stroke lightning.

Figure 28. - Lower surface impact delamination (front face).

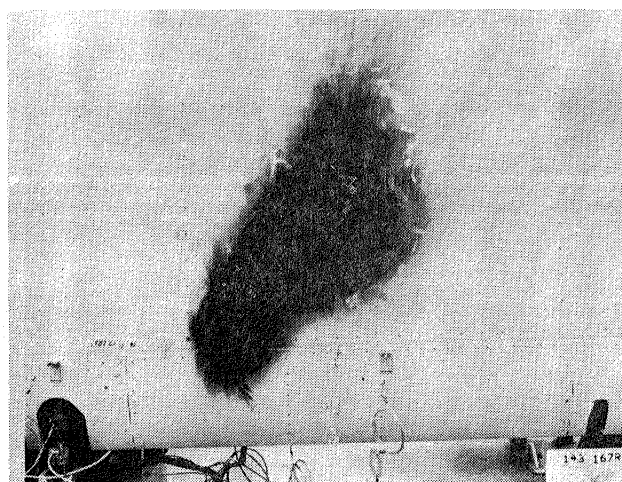
Figure 30. - Lower surface swept-stroke damage simulation.

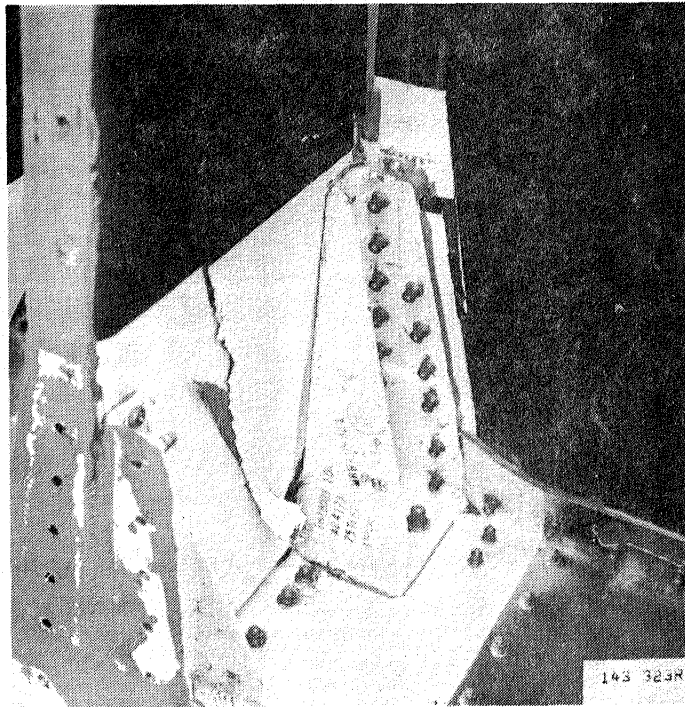
Following all of these tests the aileron was loaded to failure in the Condition 1 configuration to determine its residual static strength. Failure occurred at 130 percent of design ultimate load in the postbuckling rupture of the rib webs at stations 102.7 and 107.1, shown on figures 31 and 32. The failure mode was the same as occurred for the static test article, but the failure load was 93.5 percent of the failure load for the undamaged test article. Other than the effect of internal load redistribution there was no evidence that any of the damage sites directly contributed to the failure. Following the initial failure at 130 percent of design ultimate load the load jacks continued to apply another 9 percent of design ultimate load before the load was dumped. This overload led to the failure of the station 57.1 rib web, followed by a failure of the covers and hinge fitting forging.

Figure 31. - I.A.S. 102.7 rib web failure, residual strength test.

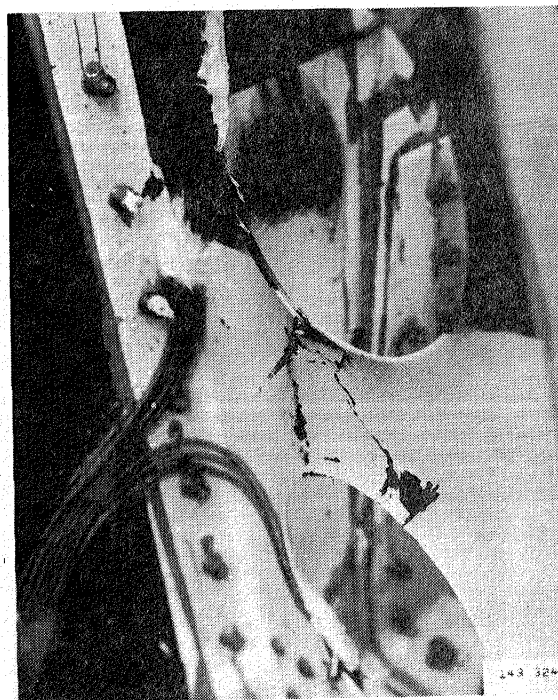
Figure 32. - I.A.S. 107.1 rib web failure, residual strength test.
